Building services in timber construction – Investigation on difficulties and reliefs during the installation procedures in multi-storey timber residential buildings

D Koppelhuber*, A Magg

Graz University of Technology, Institute of Construction Management and Economics, Lessingstraße 25, 8010 Graz, Austria

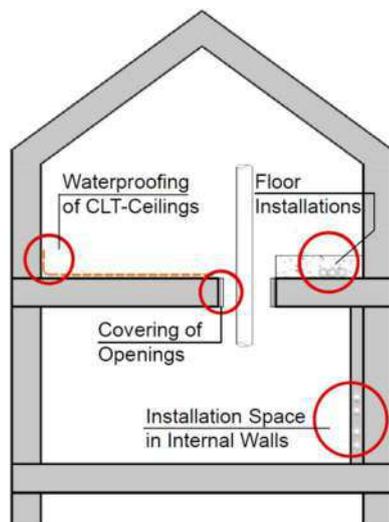
Figure 1. Problematic detail points for the installation process of building services in multi-storey timber buildings [7]

Figure 1 shows the most problematic detail points for planners and installers in Project 1: The main challenge was the waterproofing of CLT-ceilings which is required in the Austrian Standard ÖNORM B 2320:2017 – Wooden residential houses – Technical requirements [6]. So far, little attention had been paid to this new detail. In some cases, planners did not take account of the waterproofing in plans and tenders, which led to negligence in execution. If the properties and schedule of the waterproofing process are not fixed, disturbances in the assembly process and associated additional costs are the consequence. In connection with the waterproofing of CLT-ceilings, new piping runs on the floors must also be taken into account or even better, the pipelines are completely installed in internal walls or as wall surface installations. These details require more space in internal walls, which must early be considered.

Another challenging new timber-specific detail was the covering of openings in CLT-ceilings to gain an appropriate fire protection in installation shafts. The enumerated detail points are just a few excerpts from the list of challenges and problems that had arisen due to incomplete plans, tenders and the lack of training of the installers.
