To cite this article: D Koppelhuber and A Magg 2020 *IOP Conf. Ser.: Mater. Sci. Eng.* **800** 012031

# Building services in timber construction – Investigation on difficulties and reliefs during the installation procedures in multi-storey timber residential buildings

Graz University of Technology, Institute of Construction Management and Economics, Lessingstraße 25, 8010 Graz, Austria

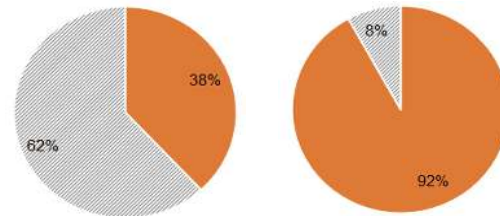
**Classification of dysfunctions**

General dysfunctions
-

Timber related dysfunctions

First it was identified whether the disturbances were attributable to timber construction or whether they would also occur in a solid construction such as brick or concrete. Timber-specific dysfunctions are those that arise on the one hand by special new execution details, on the other hand, malfunctions due to improper tools and additional interfaces with other trades. General disturbances are e.g. planning errors (missing information) but also waiting times caused by inadequate working layout or correction of execution errors.

**Table 2.** Share of timber-constructions related dysfunctions and field of responsibility of dysfunctions [5]

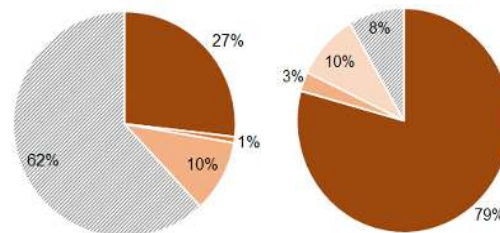
**Cause of dysfunctions in timber constructions**

Caused by planning
-

Caused by working layout
-

Caused by construction monitoring and site management
-

Caused by assembly line production
-

General interruptions

Table 2 shows the results of the field of responsibility of the disturbances in the individual spheres of planning (architectural and buildings services), construction monitoring and site management, working layout and prefabrication (considered for project 2).

Causes of the high number of disturbances in the area of planning were e.g. extensive drilling in aluminium and steel profiles within plasterboard walls, as the pipelines in internal walls were not planned. That means, that the dimensions of the walls and aluminium profiles were too small and no installation space considered. Also, boreholes through CLT-walls, which are very complicated to perform without suitable tools, have not been considered separately in the plans.

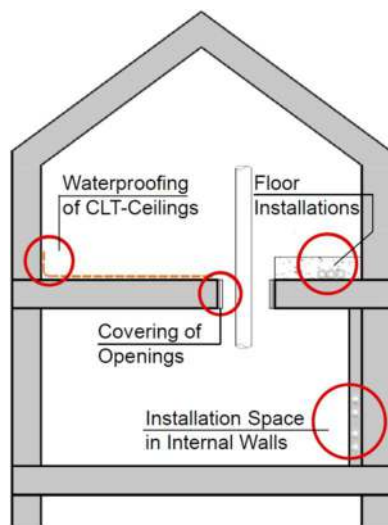
**Figure 1.** Problematic detail points for the installation process of building services in multi-storey timber buildings [7]

Figure 1 shows the most problematic detail points for planners and installers in Project 1: The main challenge was the waterproofing of CLT-ceilings which is required in the Austrian Standard ÖNORM B 2320:2017 – Wooden residential houses – Technical requirements [6]. So far, little attention had been paid to this new detail. In some cases, planners did not take account of the waterproofing in plans and tenders, which led to negligence in execution. If the properties and schedule of the waterproofing process are not fixed, disturbances in the assembly process and associated additional costs are the consequence. In connection with the waterproofing of CLT-ceilings, new piping runs on the floors must also be taken into account or even better, the pipelines are completely installed in internal walls or as wall surface installations. These details require more space in internal walls, which must early be considered.

Another challenging new timber-specific detail was the covering of openings in CLT-ceilings to gain an appropriate fire protection in installation shafts. The enumerated detail points are just a few excerpts from the list of challenges and problems that had arisen due to incomplete plans, tenders and the lack of training of the installers.
